# • **Transmitter Site Security**

AM Ground Systems Co.

Kevin C. Kidd, CSRE/AMD

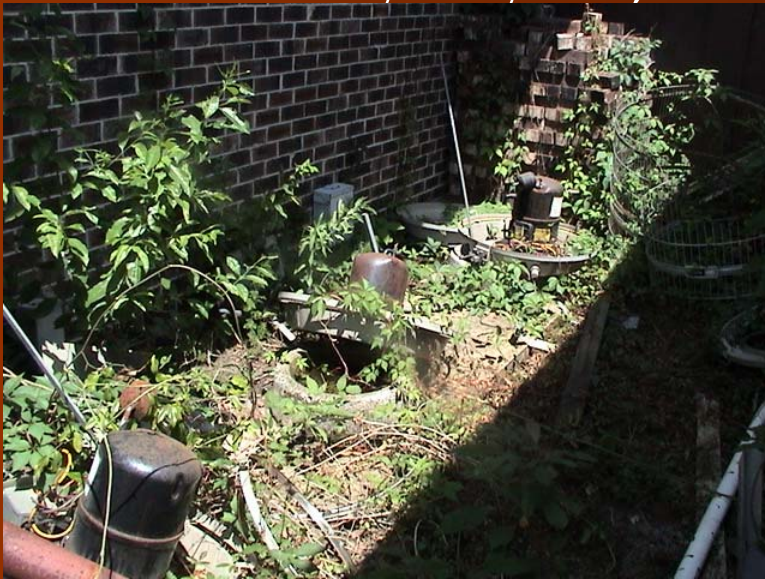
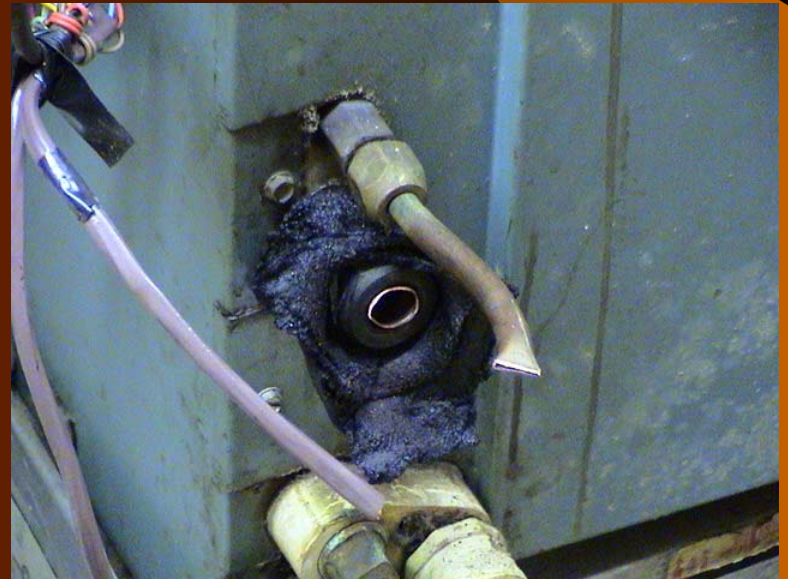
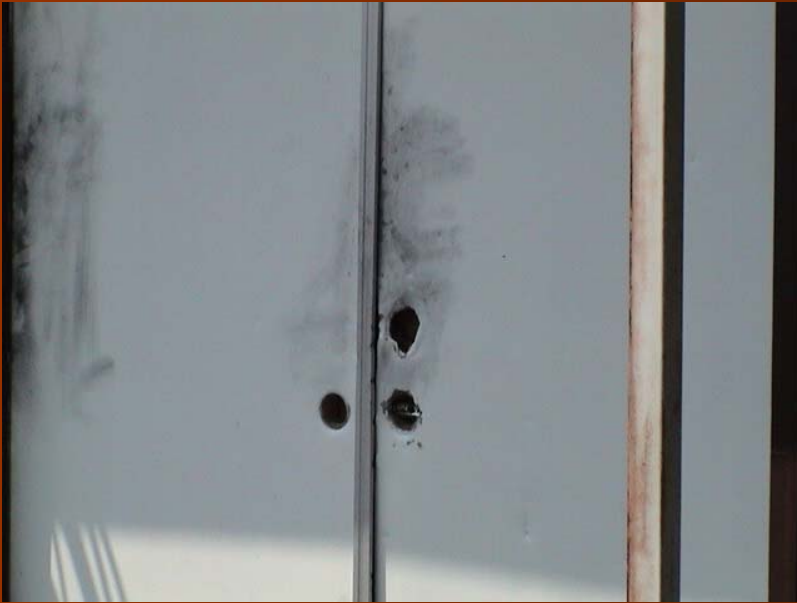
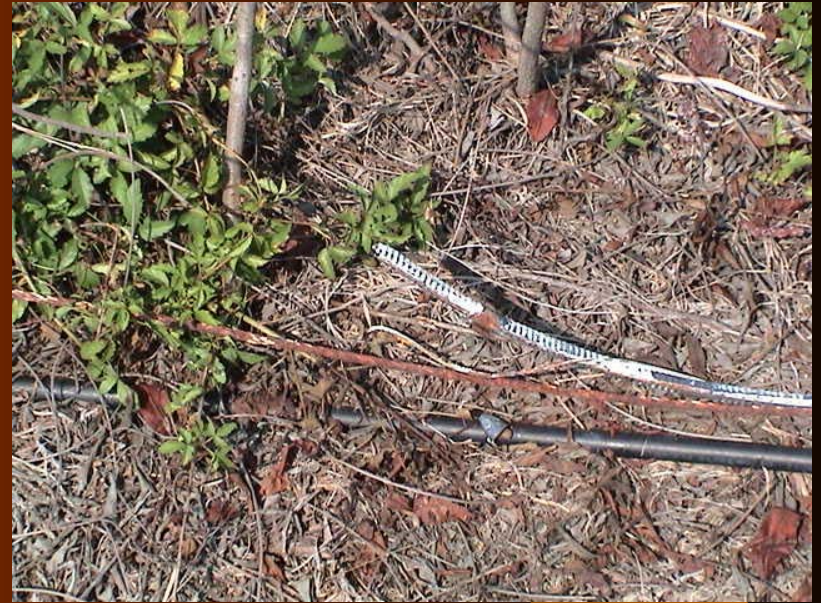
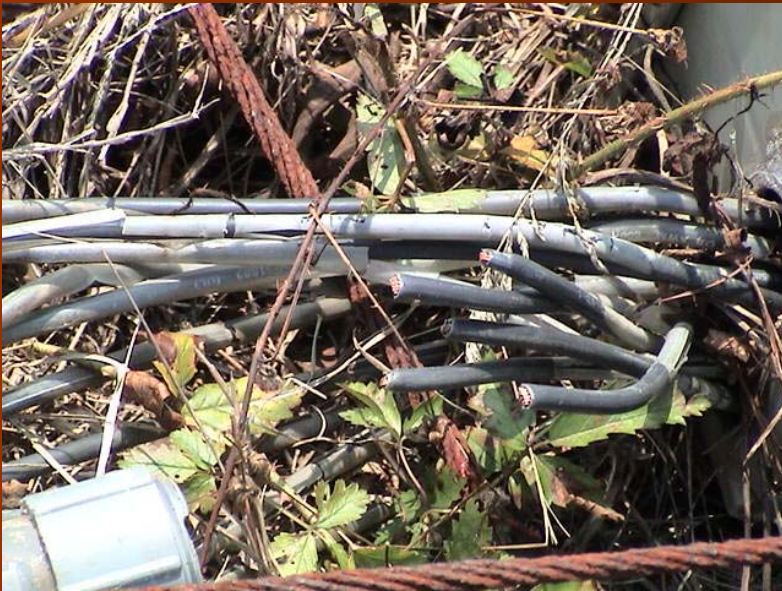
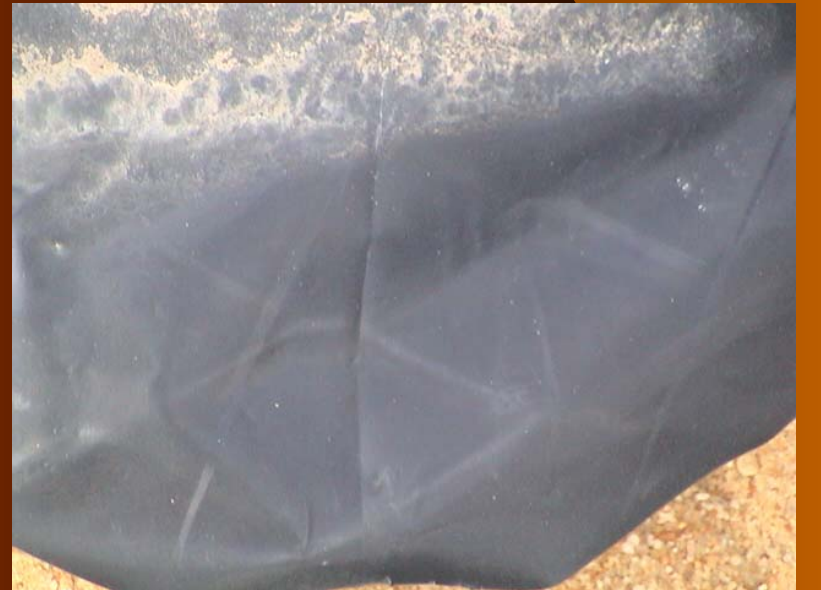
- Station personnel discovered the TX building doors broken in and obvious damage to everything copper (including numerous HVAC units, PX lines, building wiring, DA feed/sample lines, ground system, audio wiring, control wiring, water fountains, etc, etc).

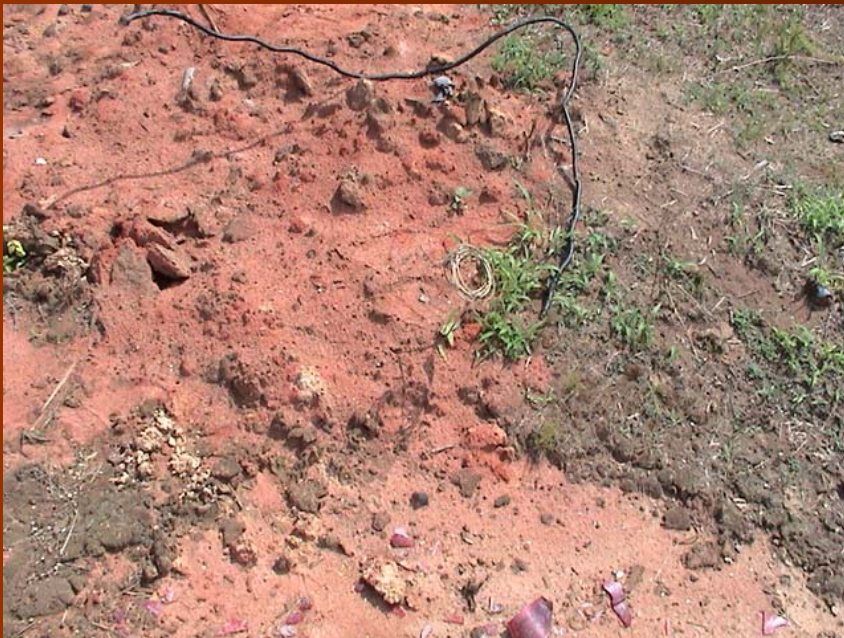
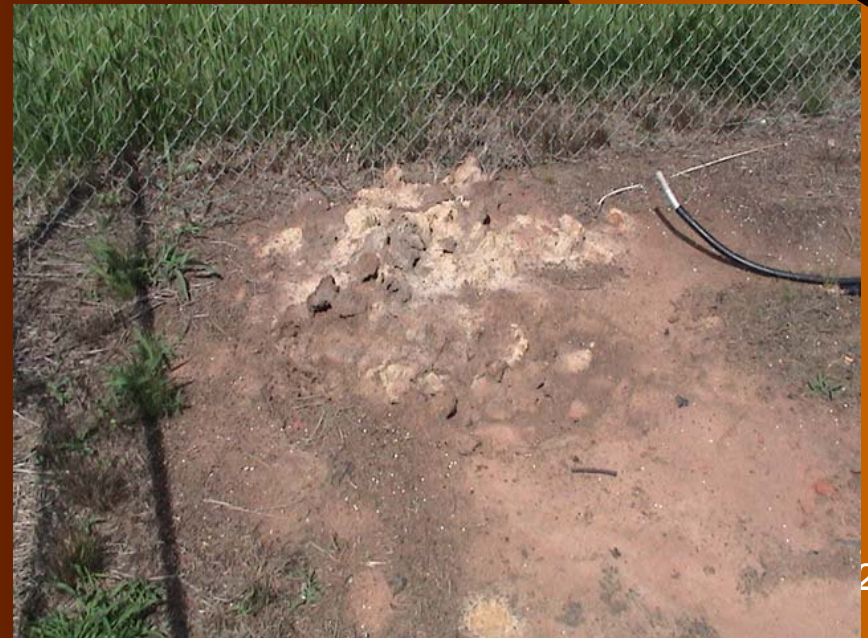
- Upon returning to the site for our second day to begin evaluation and repairs, we discovered that once again the thieves had been at work over night.
- More cops, more reports, more damage.

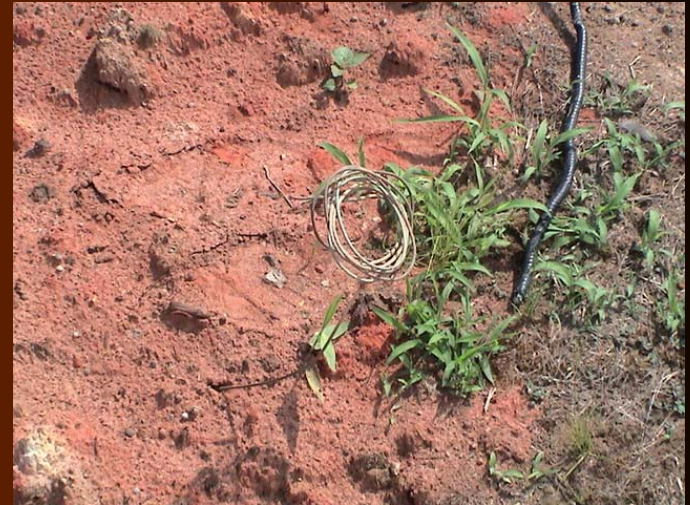
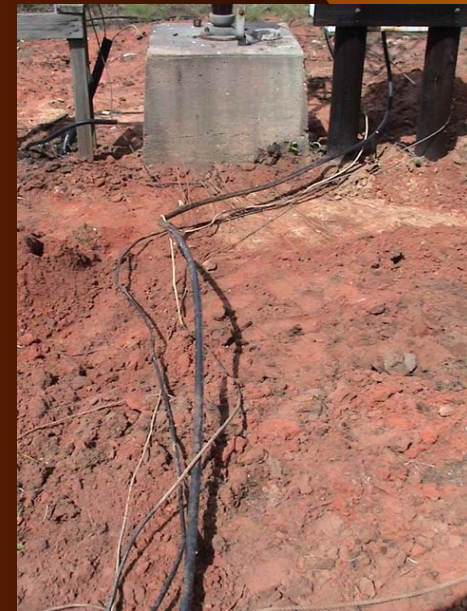
- The thieves had carefully pulled and rolled up numerous radials but had cut and dug up all of the strap they could locate. Ironically, they were very careful to avoid the sample and feed lines. No damage to the sample or feed lines was located.

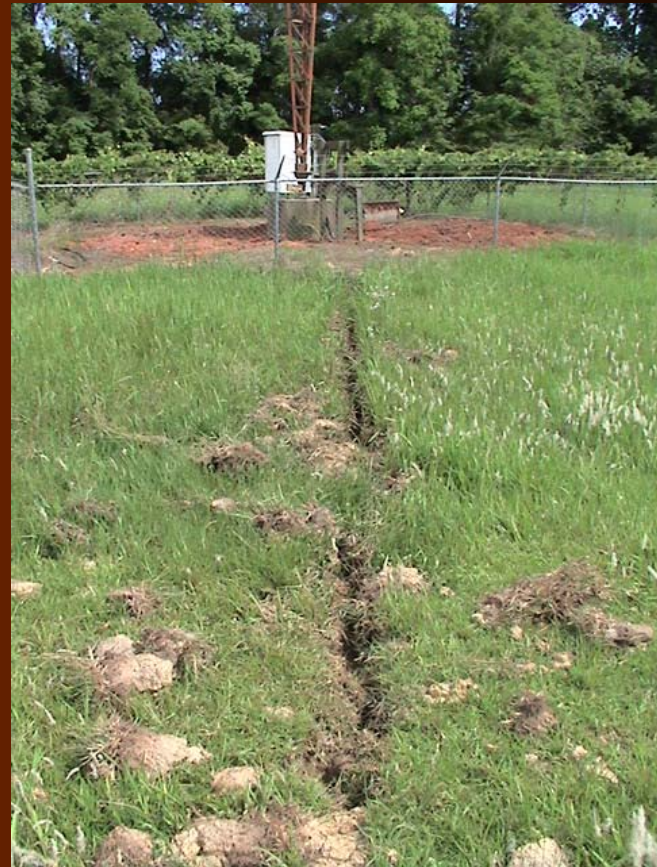
- The detectives made another round of the local recycling yards and found suspicious material at a recycler only a mile from the site.

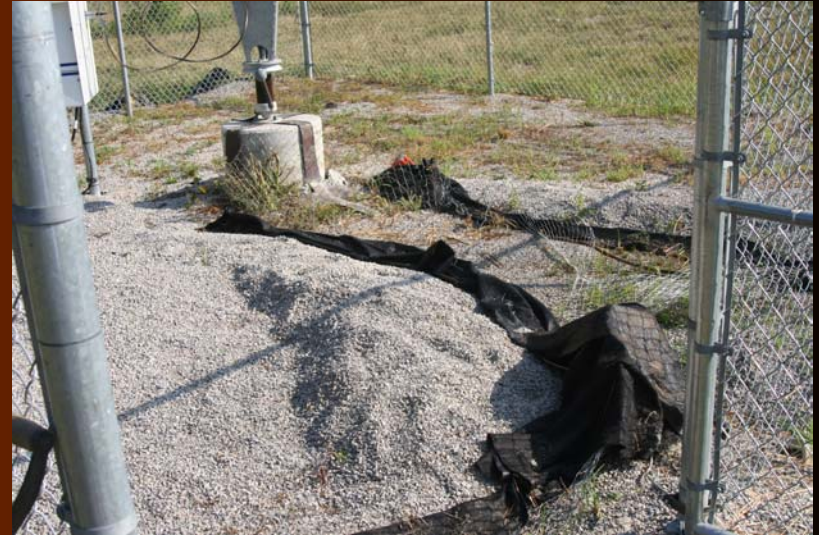
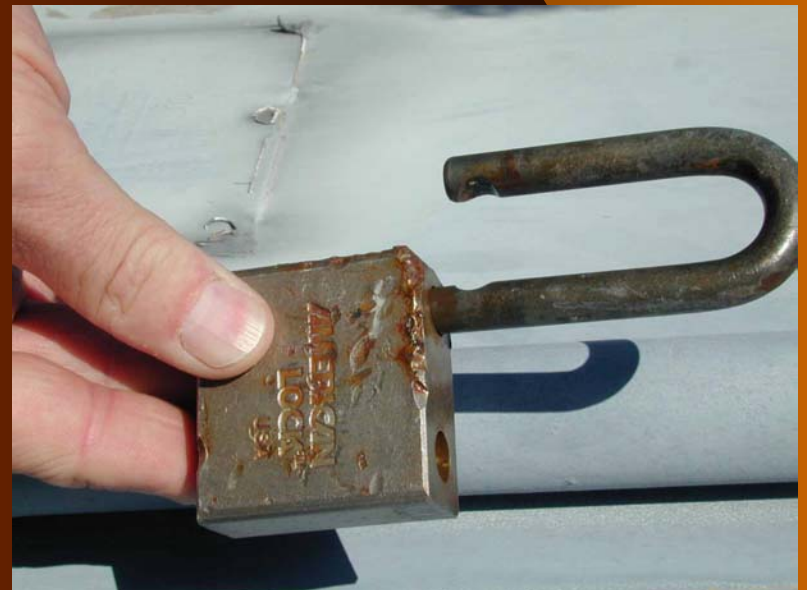
- The consulting / contract engineer was called (for the first time in months) and upon arrival at the site found tower gates open, copper missing, areas of gravel and landscape fabric pulled aside AND the transmitter and antenna monitor very unhappy.

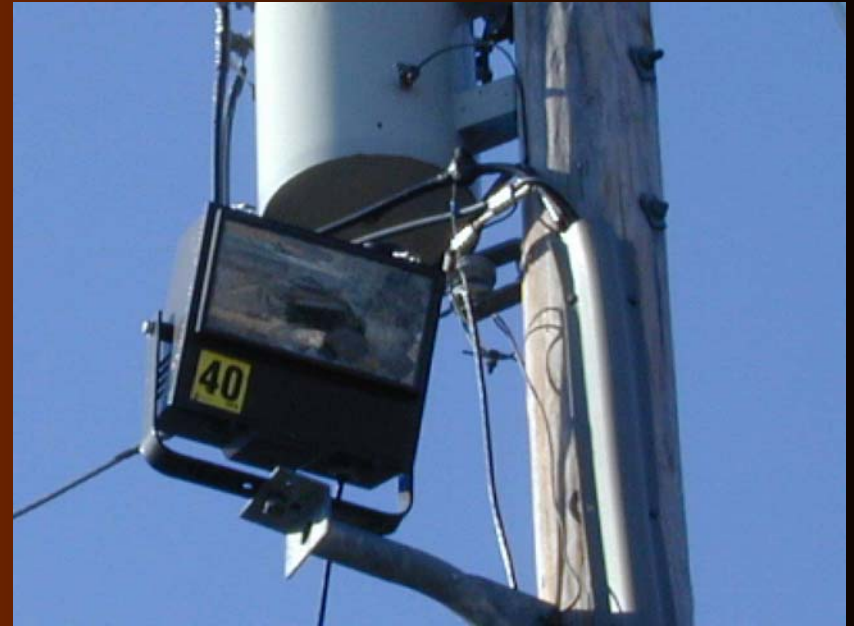
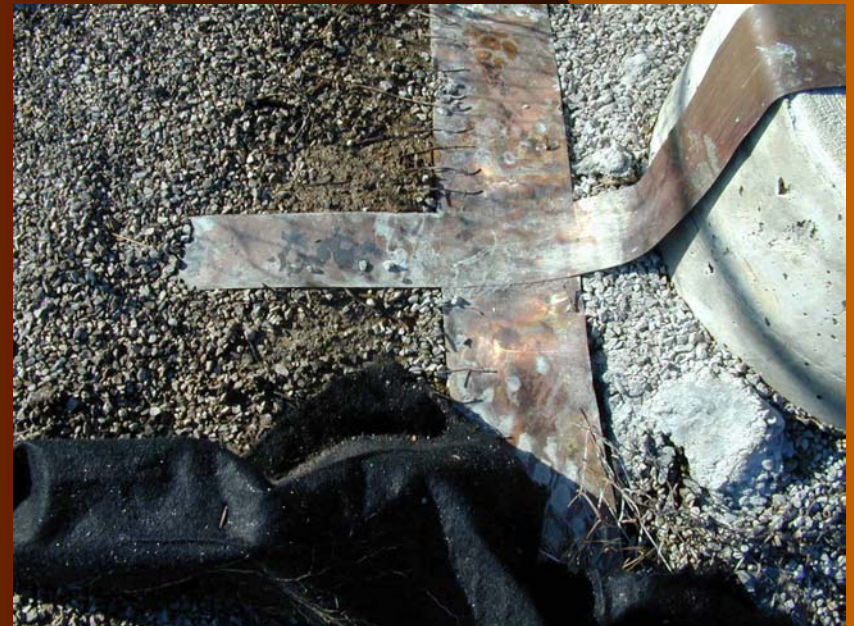
- Apparently this was the first visit by station personnel to the site in months.
- Apparently the station had not been taking readings or at least were not acting upon them.

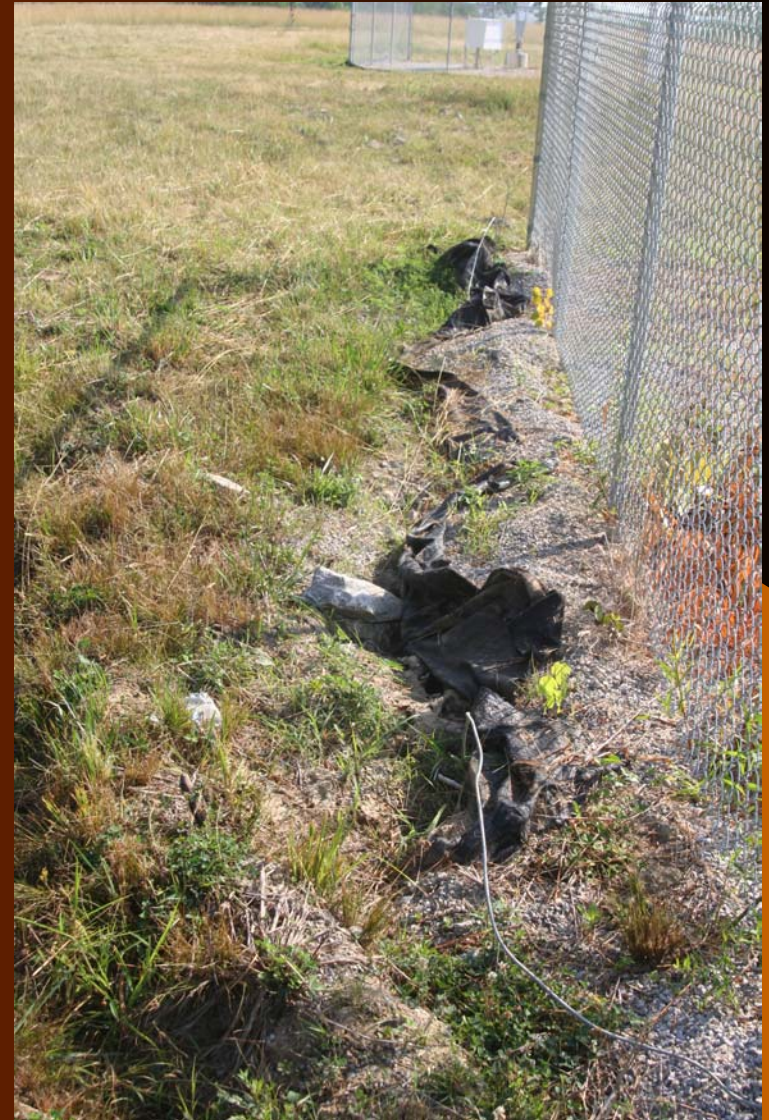
- On our arrival, we discovered not only the original damage but additional damage that had occurred sometime between the original pictures from December 2006 and the last week in May 2007.

Now the damage encompassed 3 of 5 towers  
AND the area around the transmitter  
building.
