# • **Transmitter Site Security**

AM Ground Systems Co.

Kevin C. Kidd, CSRE/AMD

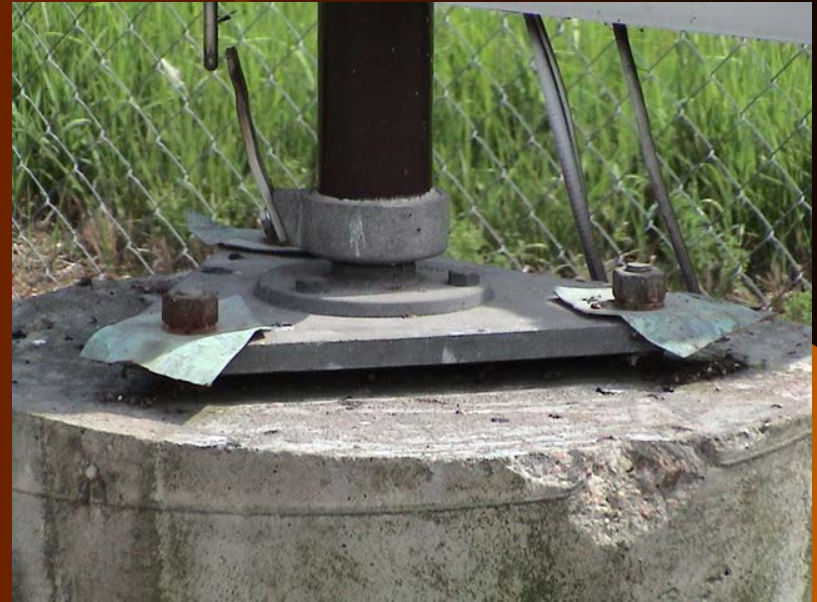
# AL Example (f)

- This recycler had purchased just over 50 lbs of copper for about \$1.50/lb. We estimate that there was around 200 lbs of copper stolen. The thief made maybe \$300 and cost the station's insurance about \$45k to rebuild.
- $\$300 / (4 \times 8 \times 2 \text{ man hours}) = \$4.68/\text{hr}$
- $\$4.68 / \$5.15 = 90\%$  of minimum wage
- The could have been working at McDonalds for more...

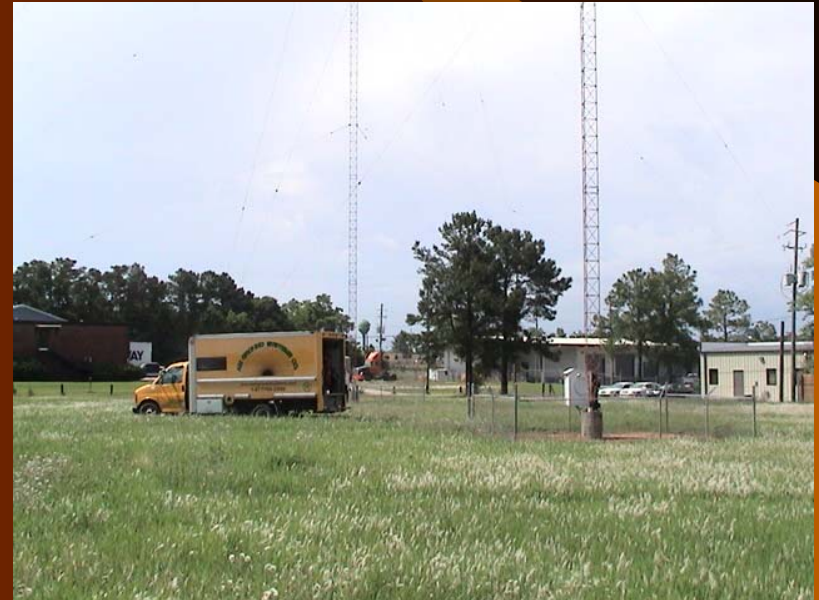
# AL Example (g)

- The recycler had recorded the sellers info and detectives knew them by name. A few hours later, the thief and an accomplice were guests of the city of Mobile.
- A local security patrol was contracted to do random site inspections and to date no further vandalism has been reported.

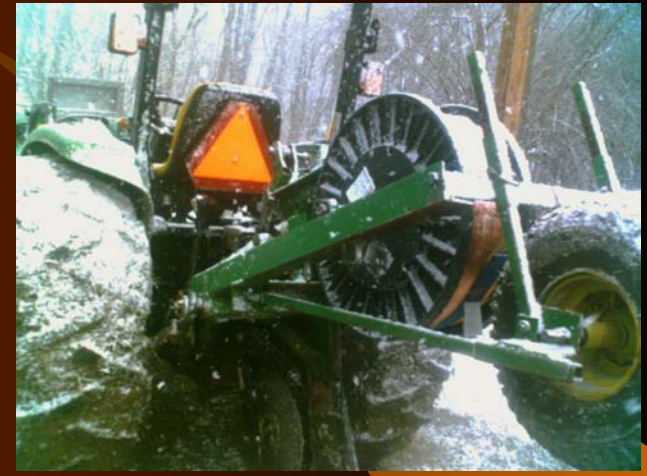
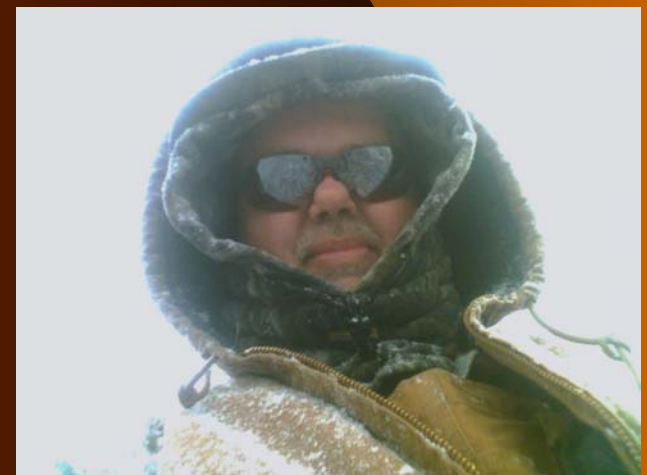
# •OH Example

- The stations CP was set to expire Spring of 2006.
- We built a 5 tower GS in late February... In Cincinnati... In the snow... 5 to 50 degrees... In a “dirty” fill disposal area... Missed Valentines Day with our various and assorted wives and girlfriends...
